Play Area Inspection _____ 11

Inspected: 10-March-2022 - 12:59 by Leon Pope RPII Annual Inspector

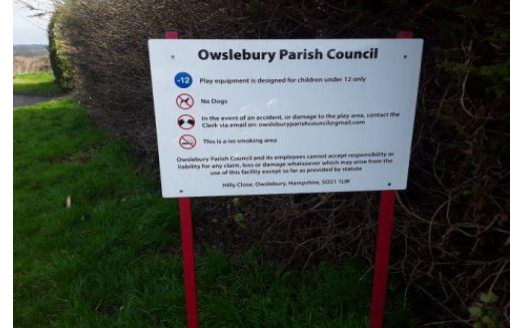
Item: Sign
Manufacturer: Owner/Operator
Surface Type: Grass
Item Quantity: 1
Equipment Compliance: N/A
Surface Area Compliance: N/A

BS EN 1176 Part 7 recommends that signage shall include emergency contact details and contact details of owner / operator for reporting maintenance issues - Provide additional information

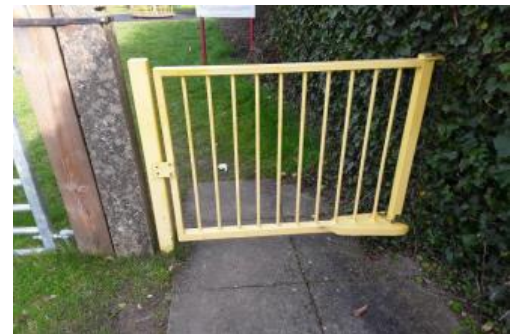
Item: Gate - Self Closing
Manufacturer: I.A.E. Fencing
Surface Type: Paving Slabs
Item Quantity: 1
Equipment Compliance: N/A
Surface Area Compliance: N/A

This item is satisfactory - no work required -

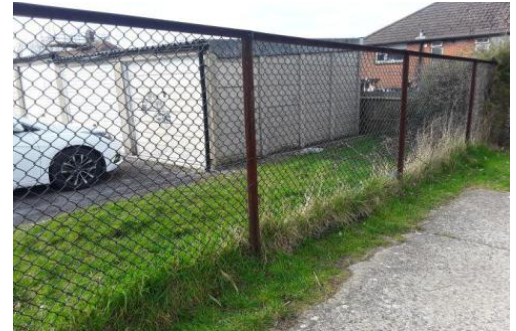
Item: Fence - Chainlink
Manufacturer: Not Identified
Surface Type: Grass
Item Quantity: 1
Equipment Compliance: N/A
Surface Area Compliance: N/A

There is surface corrosion present on the item - Consider treating the item

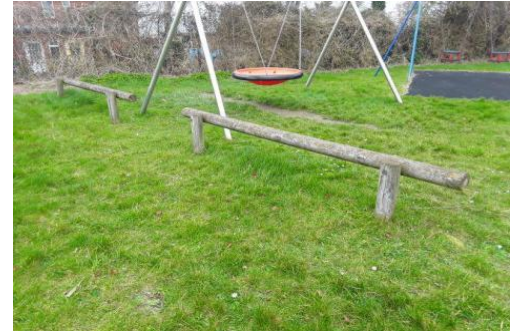
Item: Swing Barrier
Manufacturer: Playdale Playgrounds Ltd
Surface Type: Grass
Item Quantity: 1
Equipment Compliance: N/A
Surface Area Compliance: N/A

There is some evidence of rot in the timber - Monitor for any further deterioration and replace as required

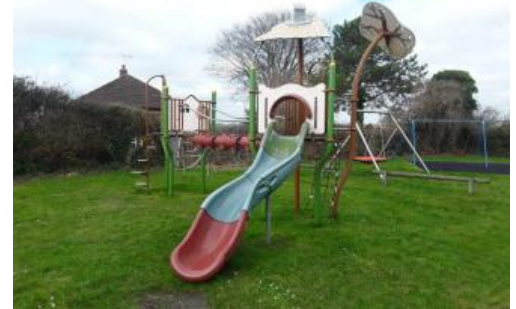
Item: Multi Play (Junior)
Manufacturer: Husson UK
Surface Type: Grass Matrix Tiles
Item Quantity: 1
Equipment Compliance: Yes
Surface Area Compliance: Yes

This item is satisfactory - no work required -

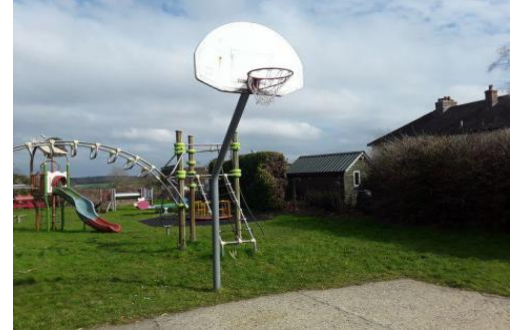
Item: Basketball Post
Manufacturer: Sure Shot
Surface Type: Bitmac
Item Quantity: 1
Equipment Compliance: Yes
Surface Area Compliance: N/A

The paintwork on this item has been damaged or worn exposing the metal underneath which is rusting - Treat any rusting components and repaint

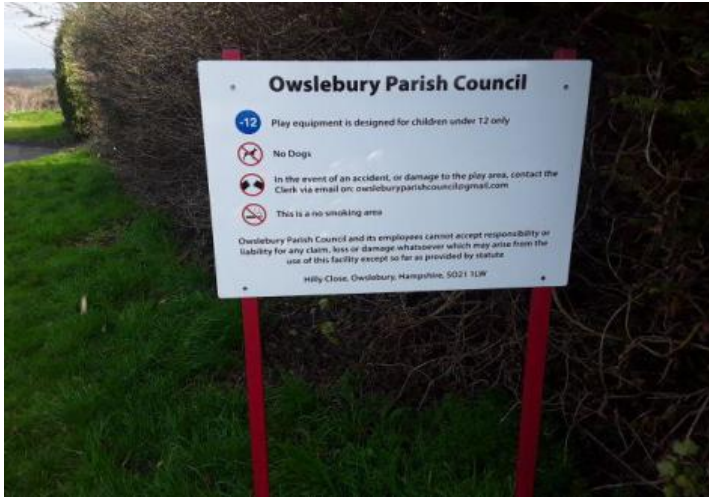
Item: Ancillary Items - Sign
Manufacturer: Owner/Operator

Finding: BS EN 1176 Part 7 recommends that signage shall include emergency contact details and contact details of owner / operator for reporting maintenance issues
Action: Provide additional information

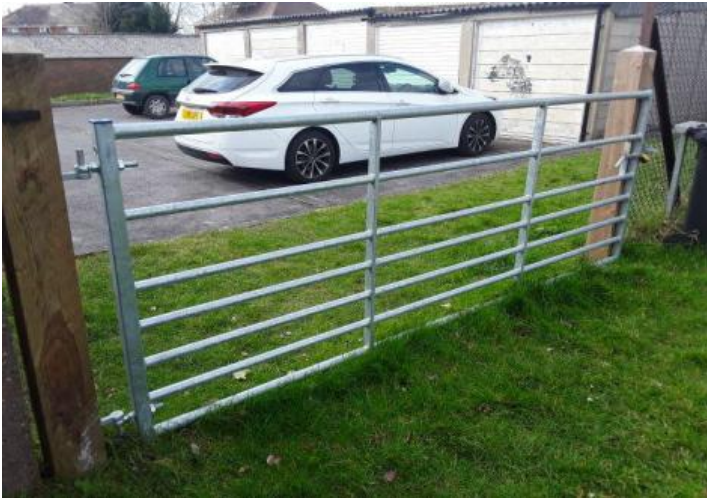
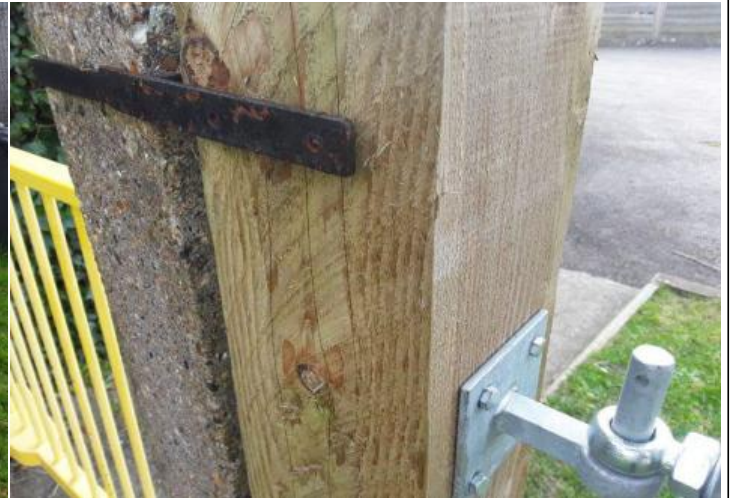
Item: Gates - Gate - Maintenance
Manufacturer: Not Identified

Finding: Parts of the timber are rough or splintered

Action: Remove all rough or sharp edges

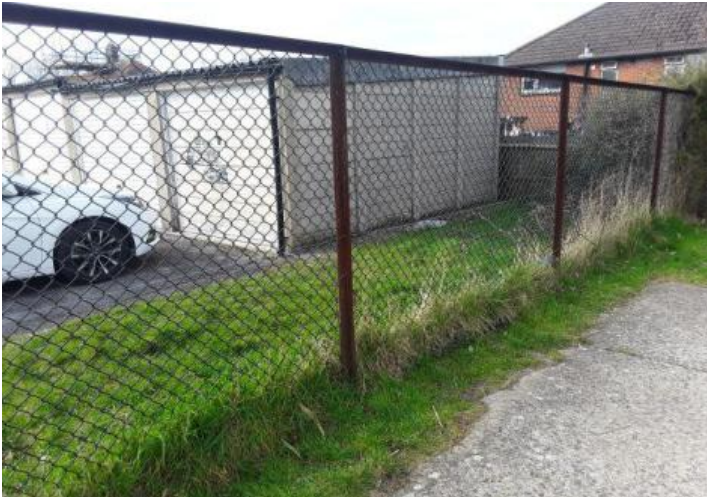
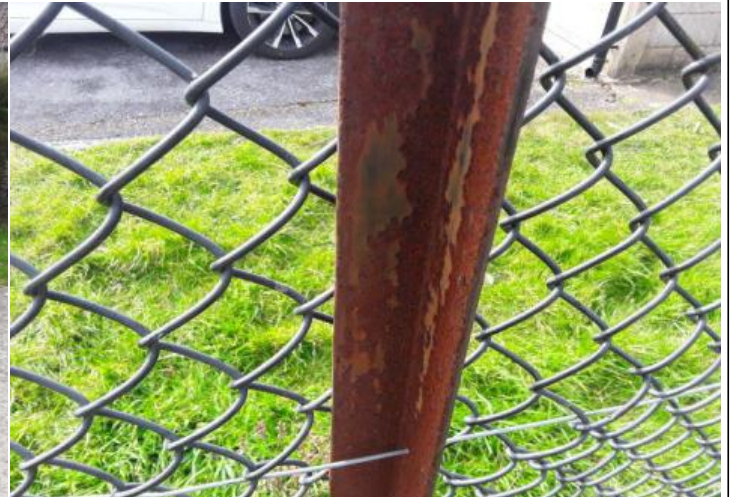
Item: Fences - Fence - Chainlink
Manufacturer: Not Identified

Finding: There is surface corrosion present on the item

Action: Consider treating the item

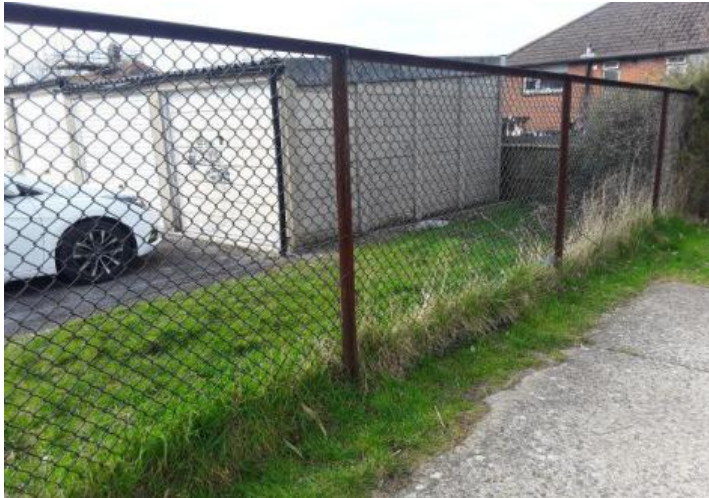
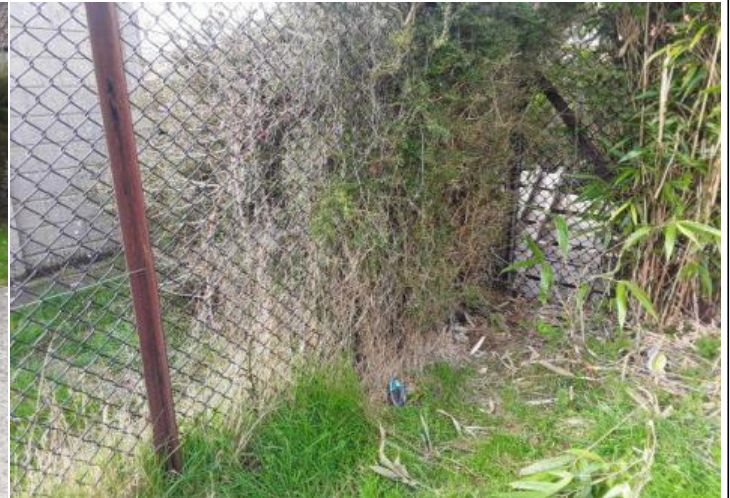
Item: Fences - Fence - Chainlink
Manufacturer: Not Identified

Finding: The adjacent foliage is overhanging

Action: Cut back and maintain

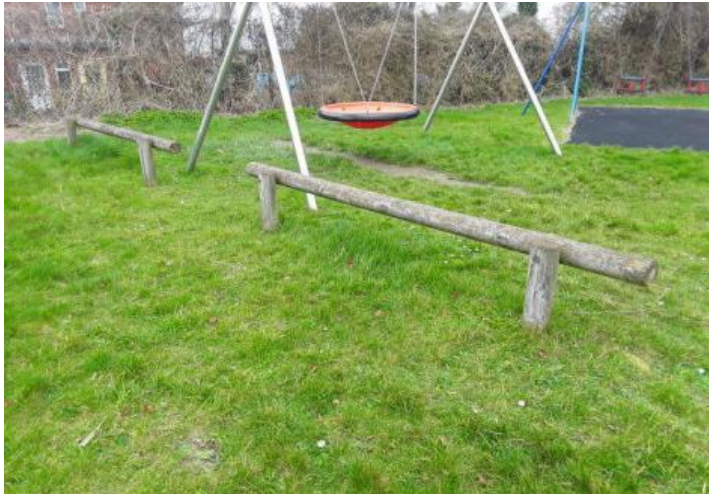
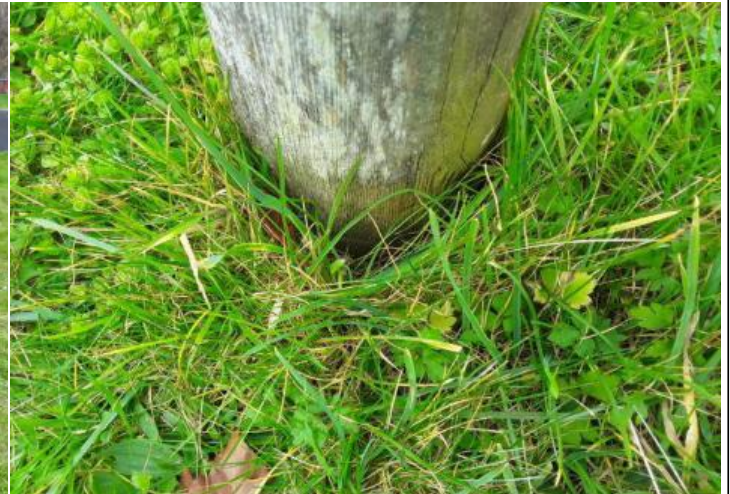
Item: Swings - Swing Barrier
Manufacturer: Playdale Playgrounds Ltd

Finding: There is some strimmer / machinery damage apparent on the posts, this can penetrate the preservative applied to the timber and accelerate the rotting process

Action: Monitor for any deterioration (rot) and replace as required

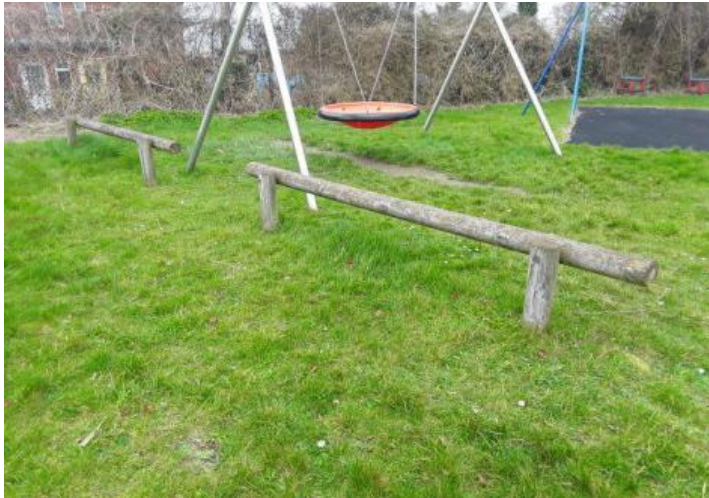
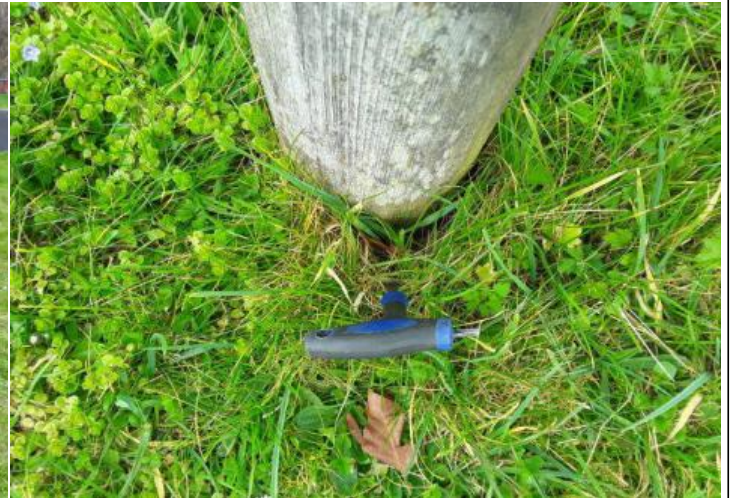
Item: Swings - Swing Barrier
Manufacturer: Playdale Playgrounds Ltd

Finding: There is some evidence of rot in the timber

Action: Monitor for any further deterioration and replace as required

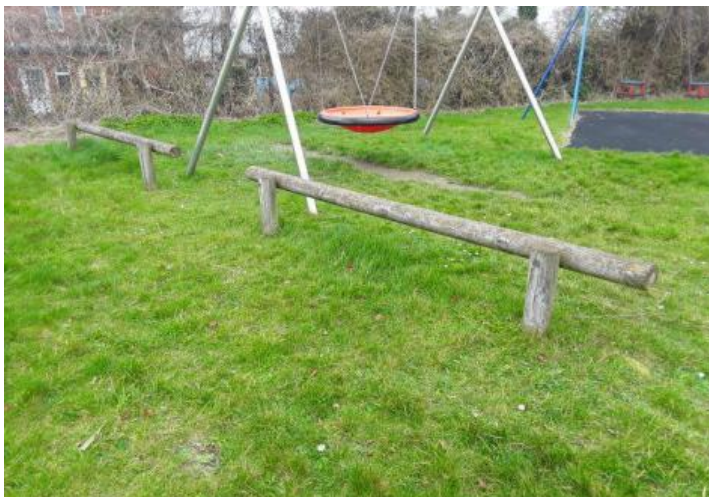
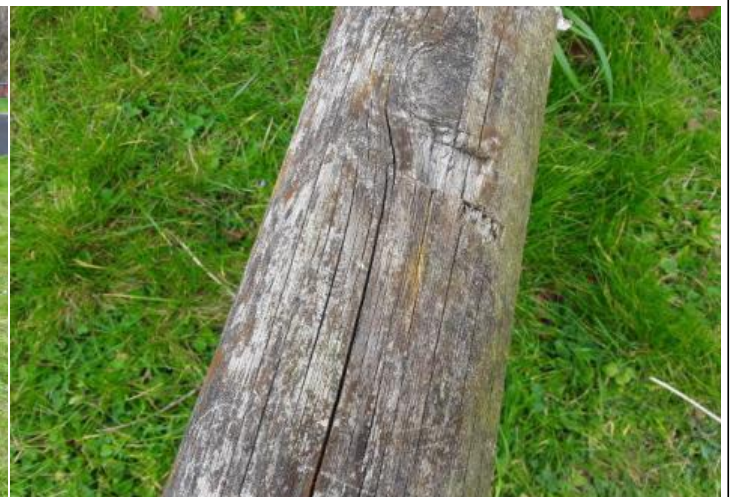
Item: Swings - Swing Barrier
Manufacturer: Playdale Playgrounds Ltd

Finding: Parts of the timber are rough or splintered

Action: Remove all rough or sharp edges

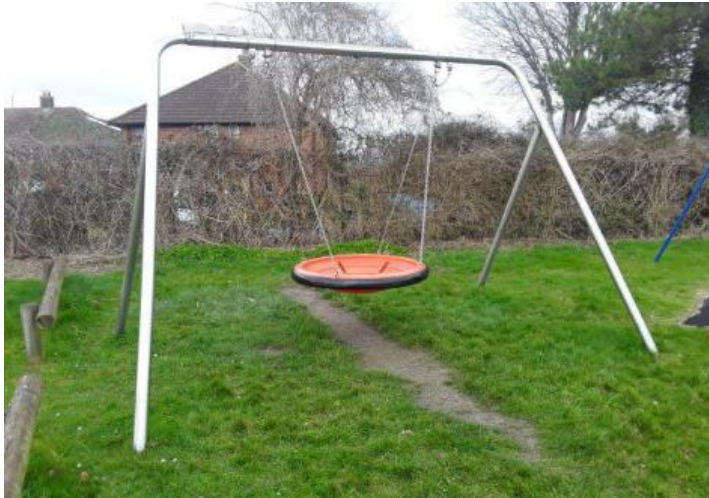
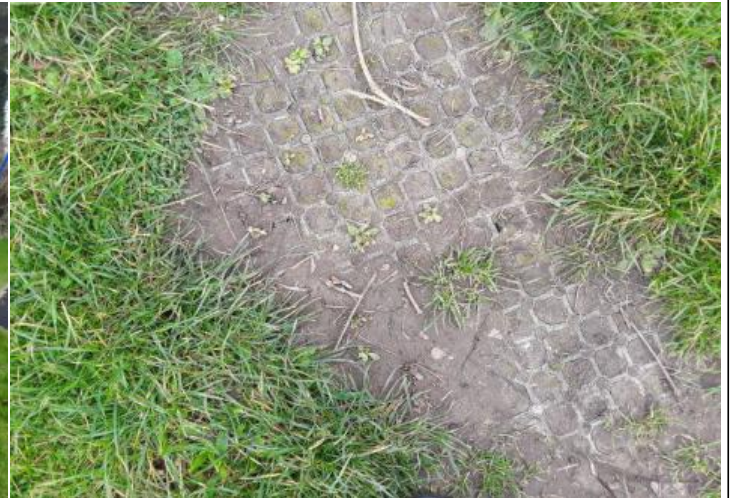
Item: Swings - Basket Swing - Type 1
Manufacturer: Playdale Playgrounds Ltd

Finding: The grass mats are silted up and the soil is compacted; this may have an effect on the impact absorbing properties of the surface

Action: Consider HIC testing impact absorbing properties to ensure the correct surface qualities are maintained for the equipment and replace as required

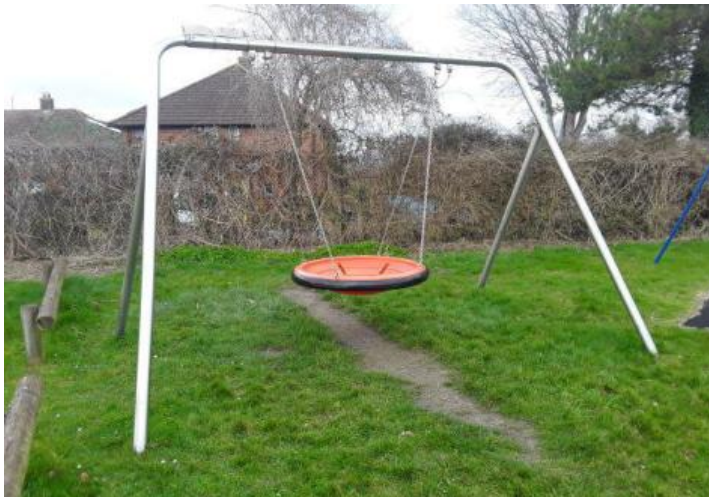
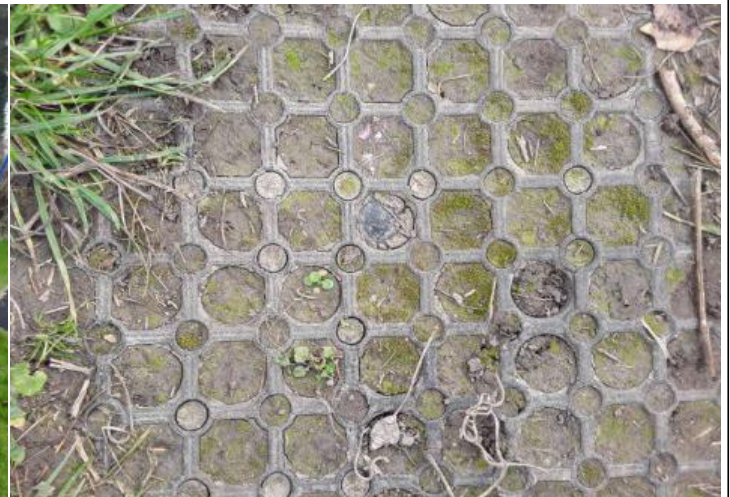
Item: Swings - Basket Swing - Type 1
Manufacturer: Playdale Playgrounds Ltd

Finding: Fixing Pins have been installed in the impact areas of the grass mats

Action: Remove pins from impact areas

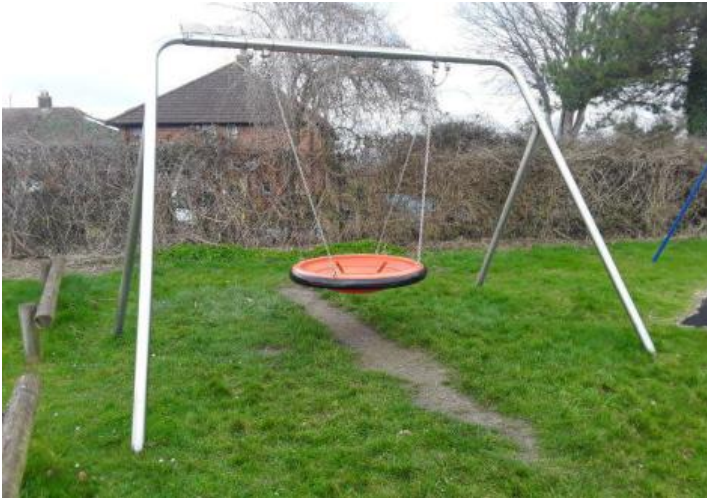
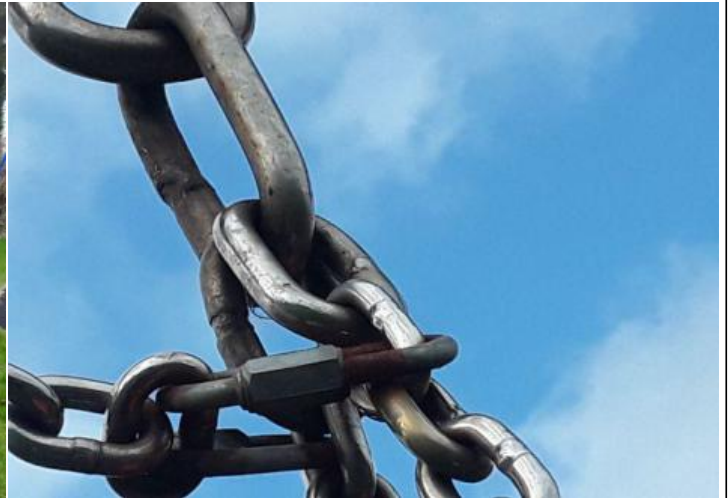
Item: Swings - Basket Swing - Type 1
Manufacturer: Playdale Playgrounds Ltd

Finding: There is some notable evidence of chain wear

Action: Monitor for any further deterioration and replace when 40% worn

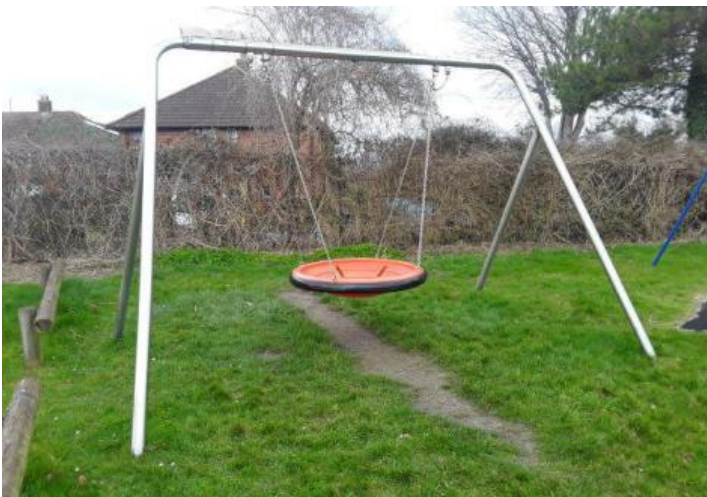
Item: Swings - Basket Swing - Type 1
Manufacturer: Playdale Playgrounds Ltd

Finding: A number of crossbar fixing(s) have worked loose

Action: Secure all loose fixings

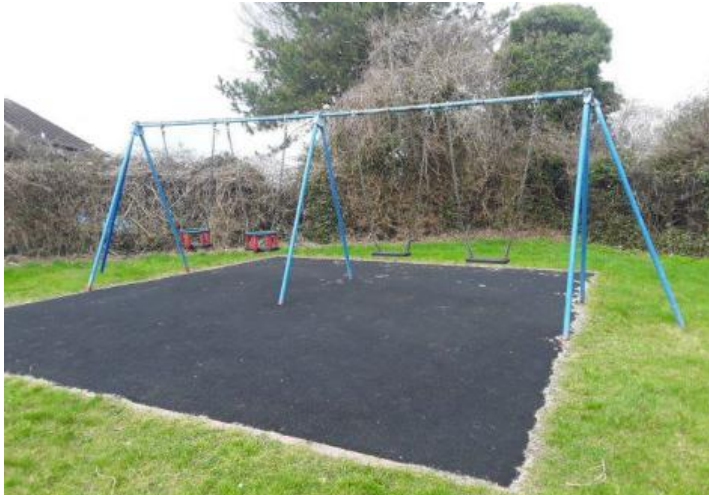
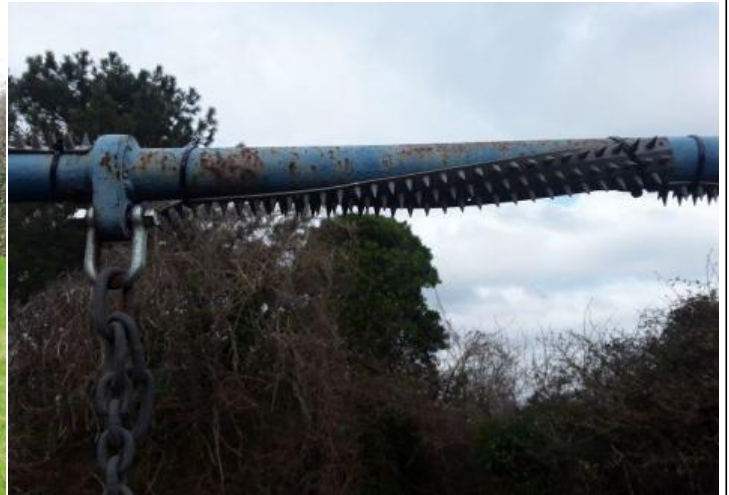
Item: Swings - 2 Bay (2 Flat, 2 Cradle)
Manufacturer: Wicksteed Playgrounds

Finding: The anti-roosting spikes have slipped out of position

Action: Resecure

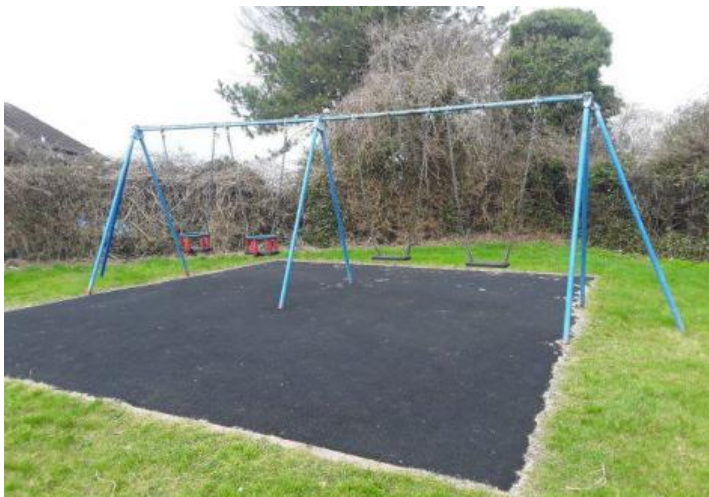
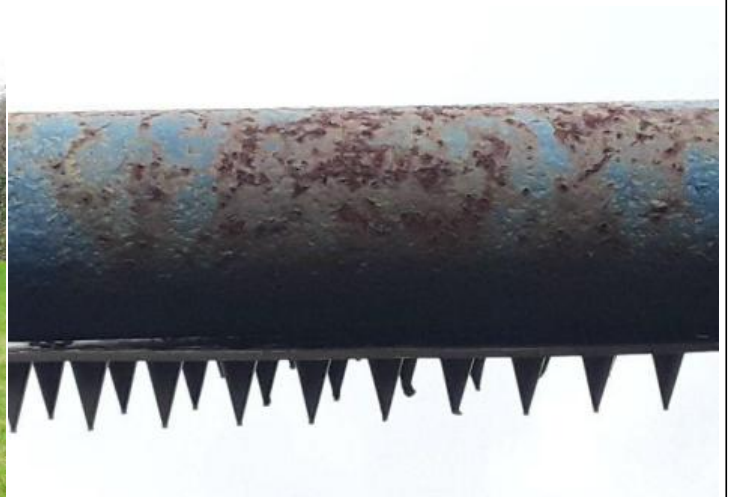
Item: Swings - 2 Bay (2 Flat, 2 Cradle)
Manufacturer: Wicksteed Playgrounds

Finding: The paintwork on this item has been damaged or worn exposing the metal underneath which is rusting

Action: Treat any rusting components and repaint

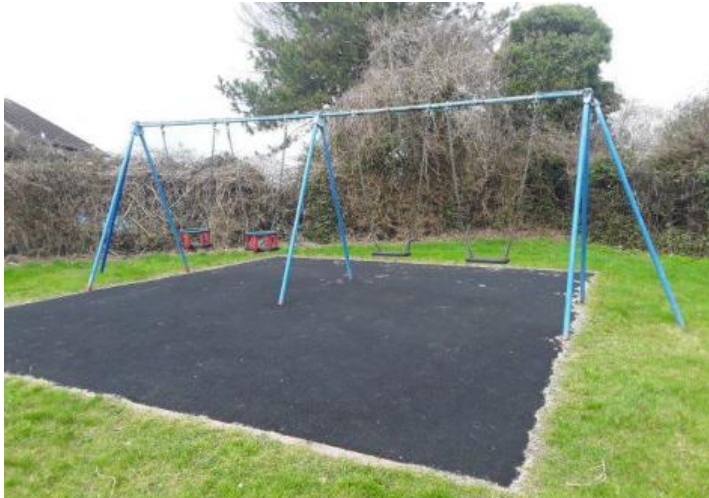
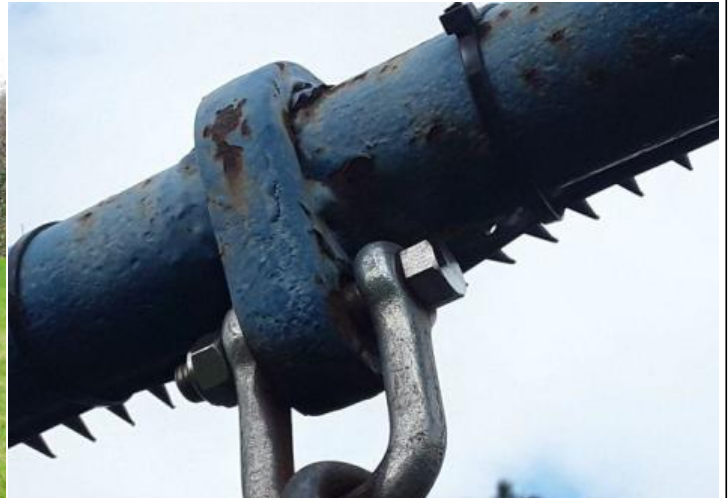
Item: Swings - 2 Bay (2 Flat, 2 Cradle)
Manufacturer: Wicksteed Playgrounds

Finding: The bushes are showing signs of wear

Action: Monitor for any further deterioration and replace as required

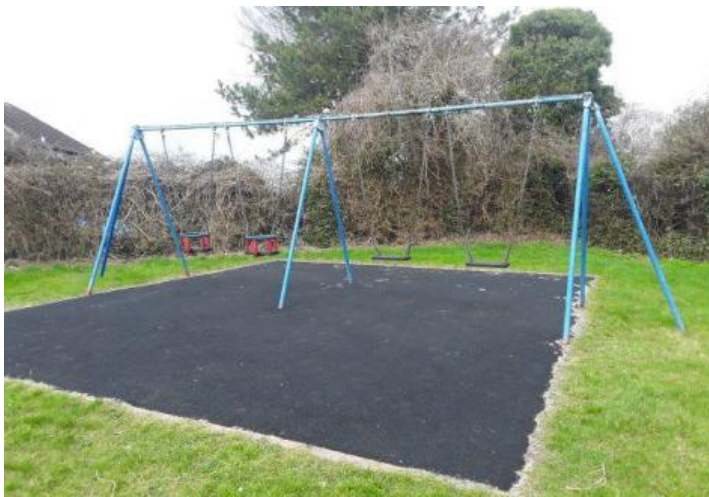
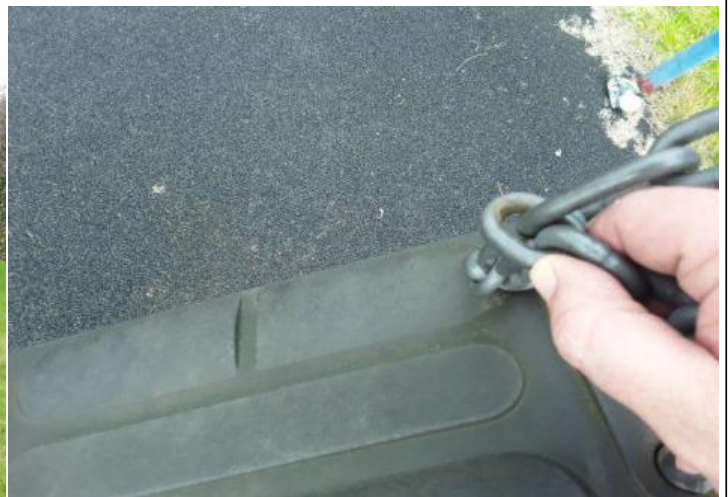
Item: Swings - 2 Bay (2 Flat, 2 Cradle)
Manufacturer: Wicksteed Playgrounds

Finding: There is some notable evidence of chain wear

Action: Monitor for any further deterioration and replace when 40% worn

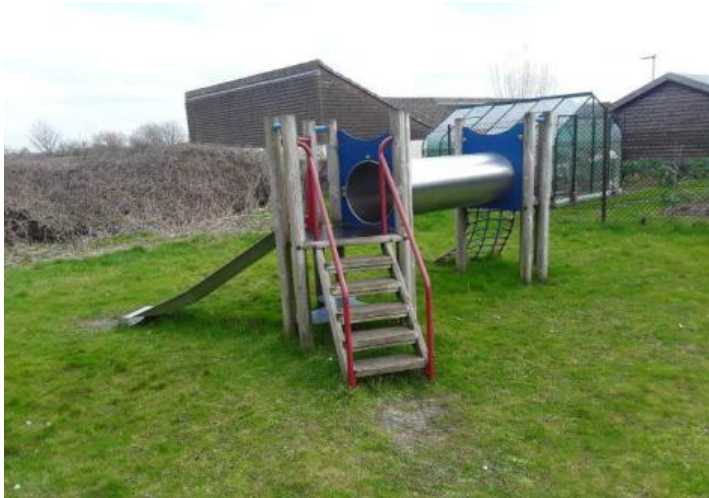
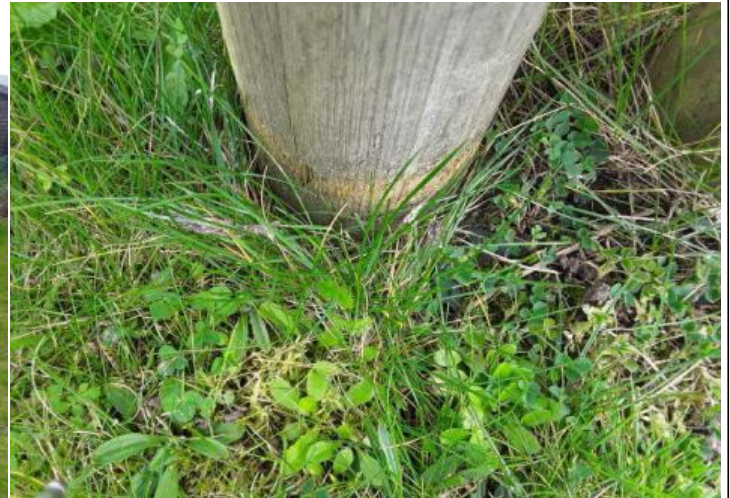
Item: Activity Equipment - Multi Play (Toddler)
Manufacturer: Playdale Playgrounds Ltd

Finding: There is some strimmer / machinery damage apparent on the posts, this can penetrate the preservative applied to the timber and accelerate the rotting process

Action: Monitor for any deterioration (rot) and replace as required

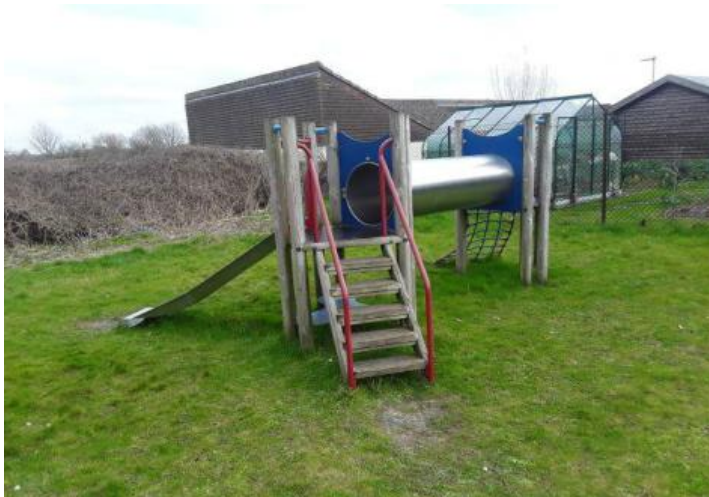
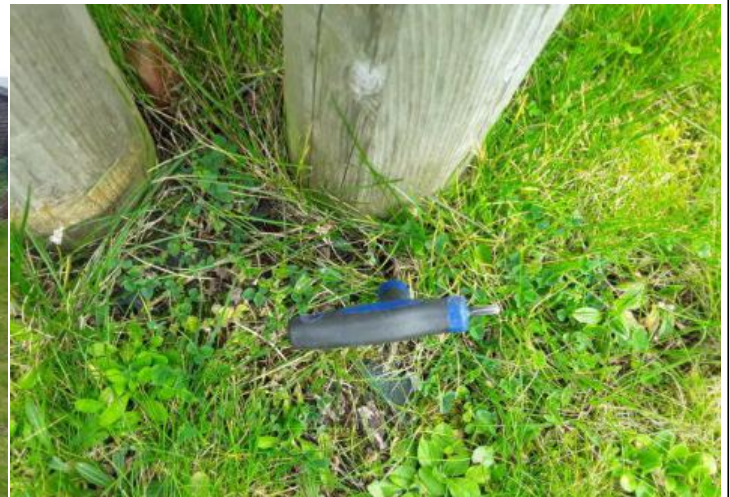
Item: Activity Equipment - Multi Play (Toddler)
Manufacturer: Playdale Playgrounds Ltd

Finding: There is some evidence of rot in the posts

Action: Monitor for any further deterioration and replace as required

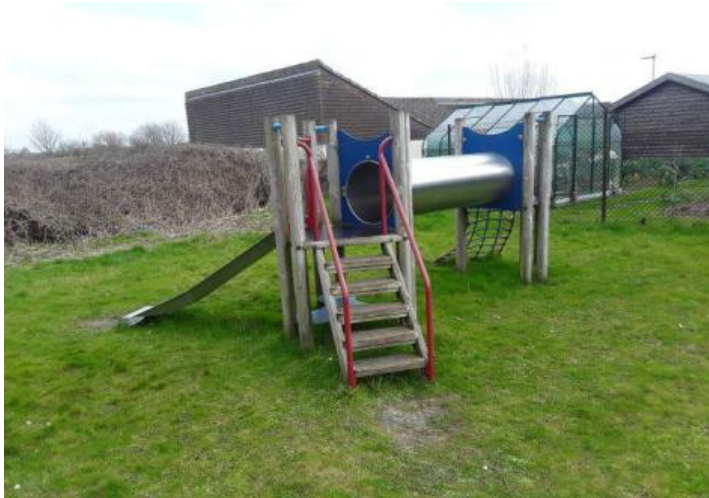
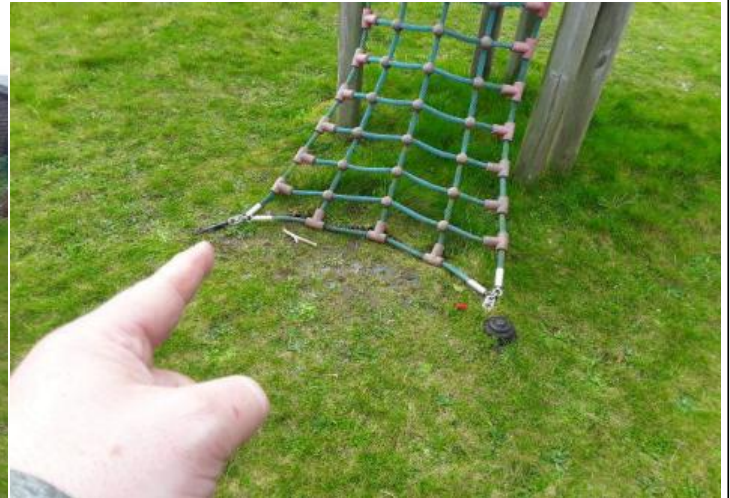
Item: Activity Equipment - Multi Play (Toddler)
Manufacturer: Playdale Playgrounds Ltd

Finding: There is a missing net mount cap

Action: Replace

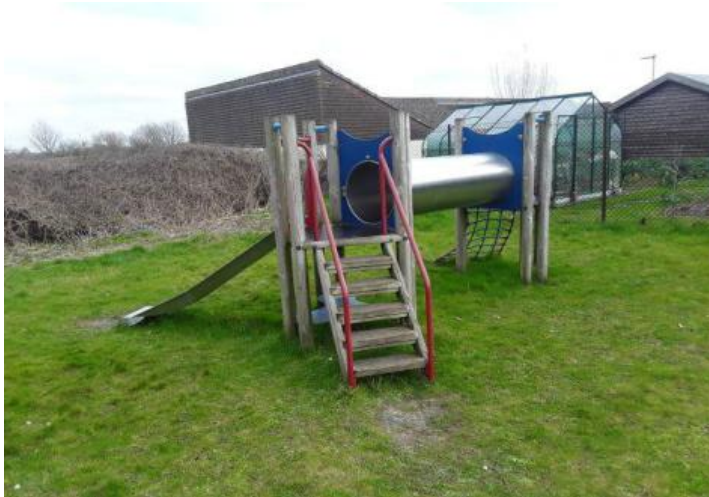
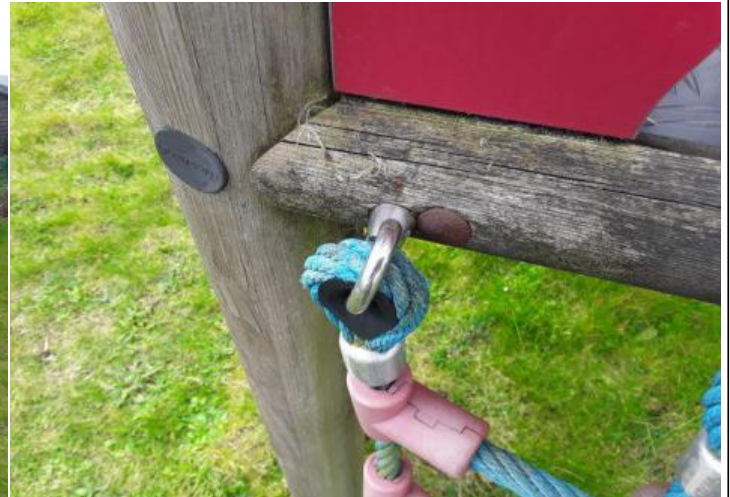
Item: Activity Equipment - Multi Play (Toddler)
Manufacturer: Playdale Playgrounds Ltd

Finding: A number of eyebolt fixing(s) have worked loose

Action: Secure all loose fixings

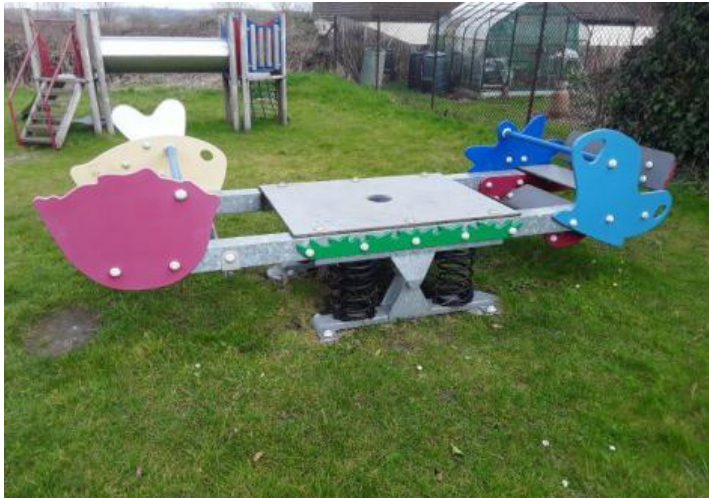
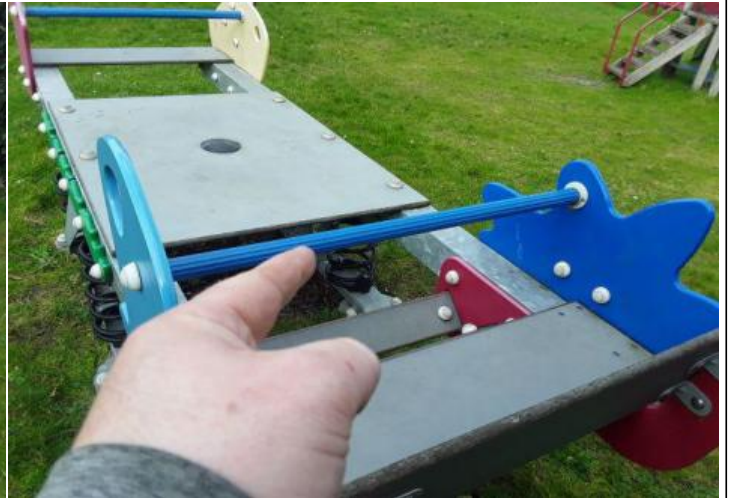
Item: Rocking Equipment - Spring See-Saw
Manufacturer: Kompan Ltd

Finding: The Handgrips/Footrests rotate and may cause an unexpected movement for the user
Action: Secure Handgrips/Footrests to prevent rotation.

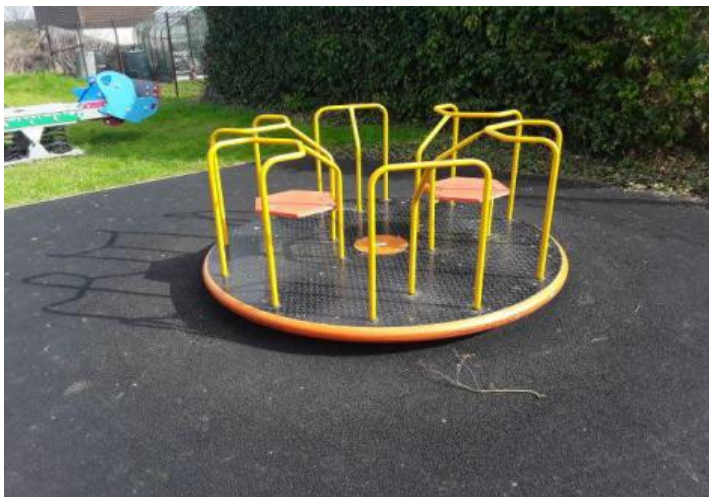
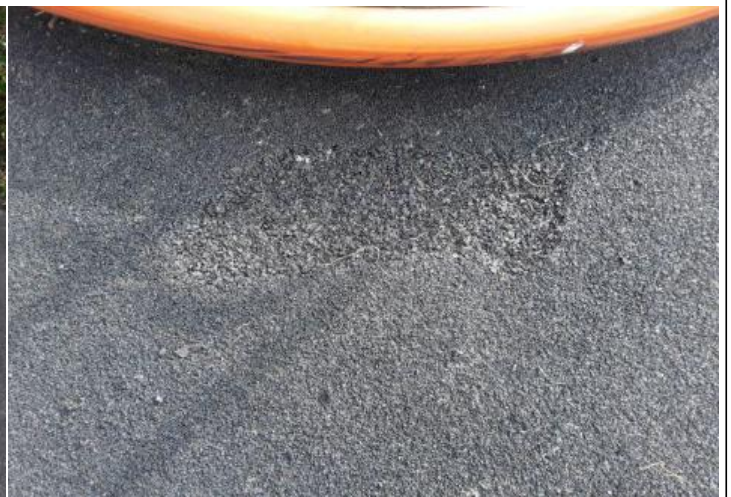
Item: Rotor Play - Roundabout
Manufacturer: Wicksteed Playgrounds

Finding: There is moderate damage to the surface
Action: Repair the damaged areas of surfacing

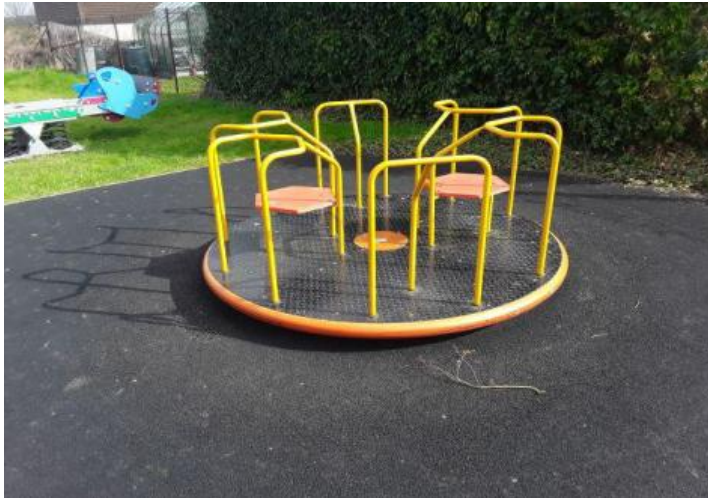
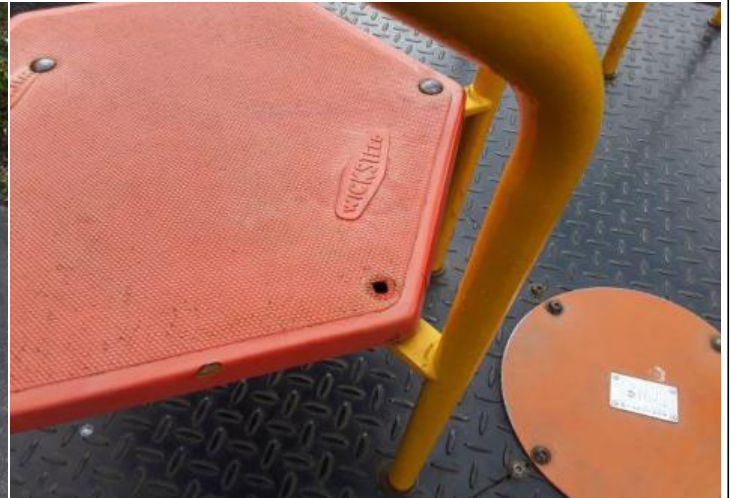
Item: Rotor Play - Roundabout
Manufacturer: Wicksteed Playgrounds

Finding: There is or are fixings missing on the item

Action: Replace all missing fixings

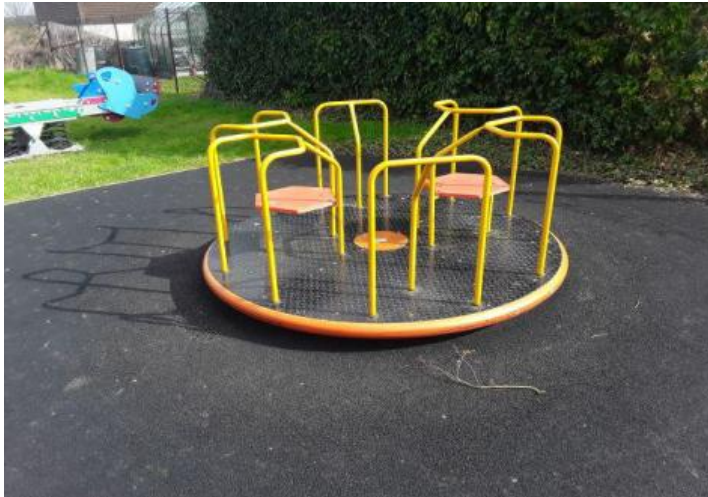
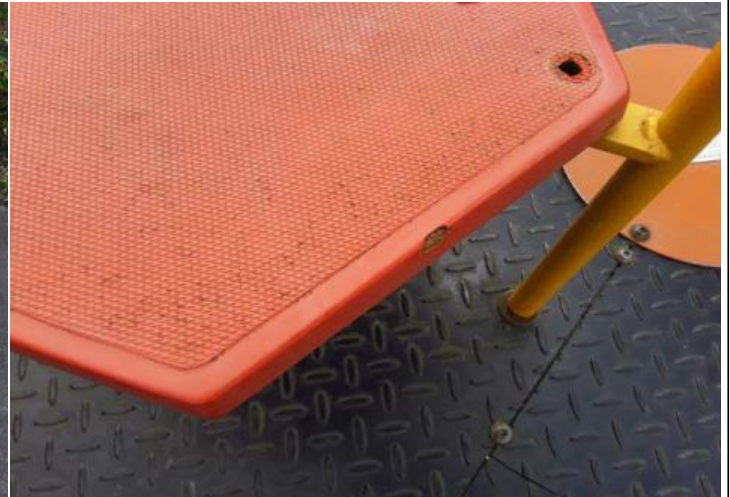
Item: Rotor Play - Roundabout
Manufacturer: Wicksteed Playgrounds

Finding: The seat has minor damage or wear

Action: Monitor for any further deterioration and replace as required

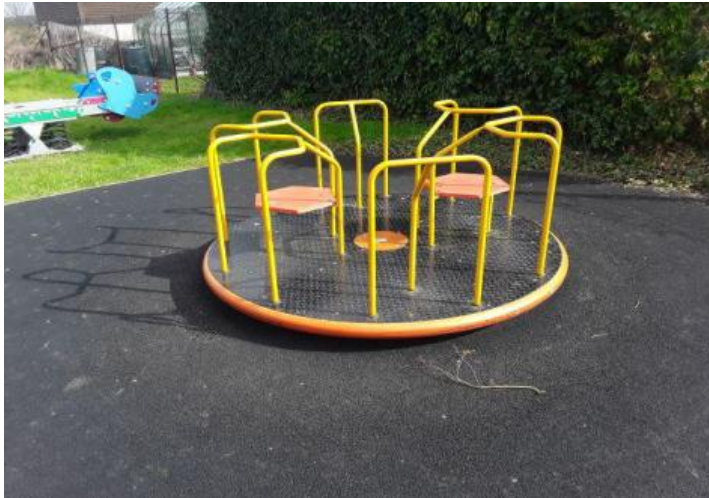
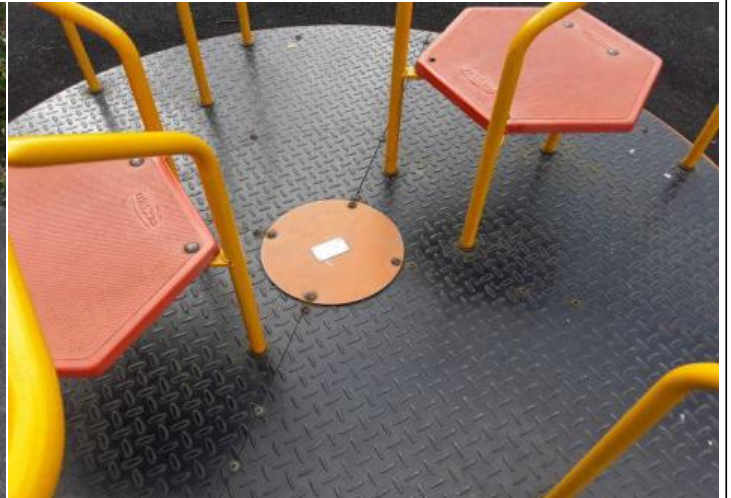
Item: Rotor Play - Roundabout
Manufacturer: Wicksteed Playgrounds

Finding: The bearing is showing signs of wear

Action: Monitor for any further deterioration and replace as required

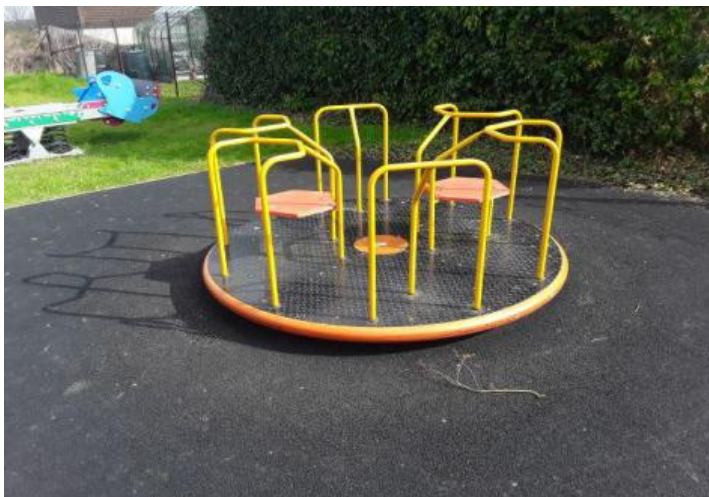
Item: Rotor Play - Roundabout
Manufacturer: Wicksteed Playgrounds

Finding: There is weed / vegetation growth on, between, or around the edges of the surfacing

Action: Remove weed / vegetation growth

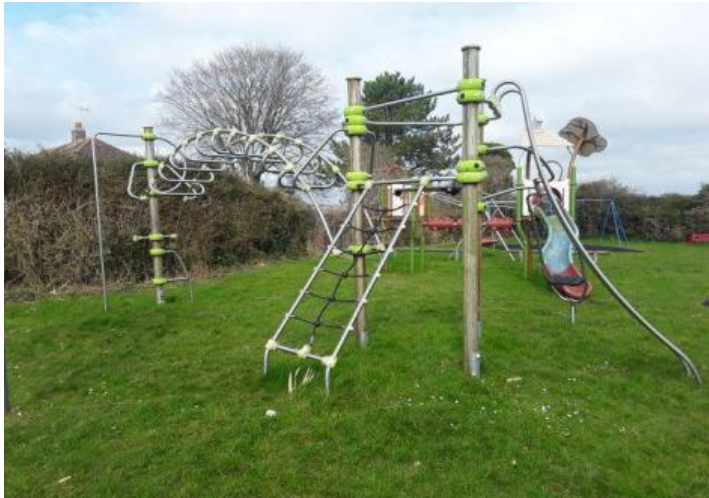
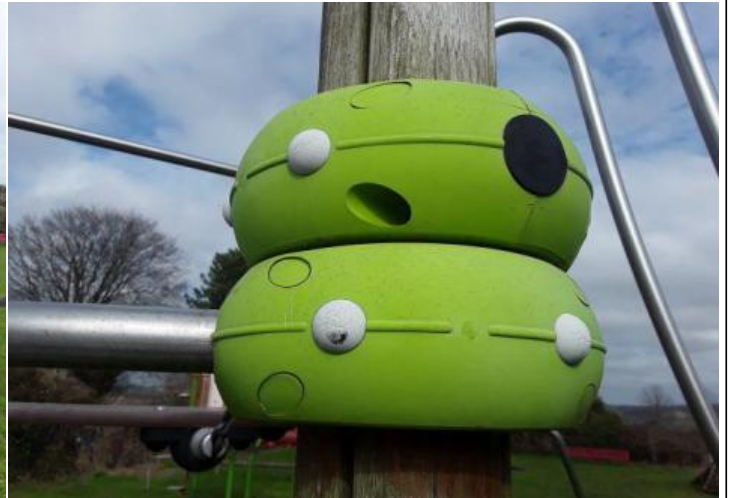
Item: Activity Equipment - Multi Play (Junior)
Manufacturer: Proludic

Finding: There is/are several inserts missing

Action: Replace missing inserts

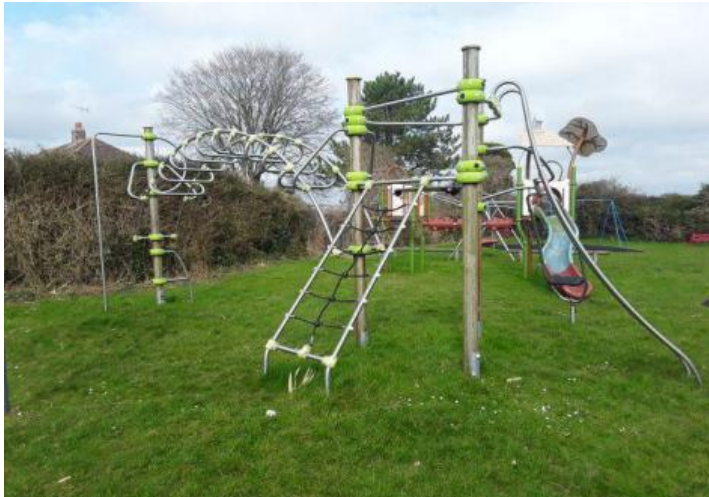
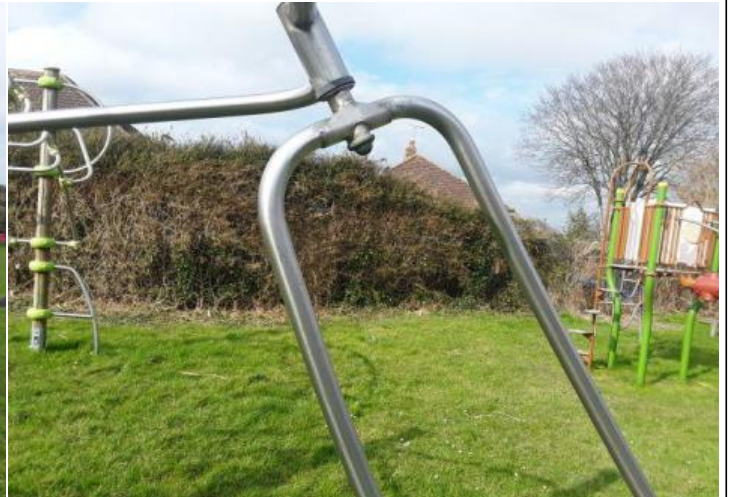
Item: Activity Equipment - Multi Play (Junior)
Manufacturer: Proludic

Finding: The bearing on the spinning platform is dry

Action: Service and lubricate the bearing(s)

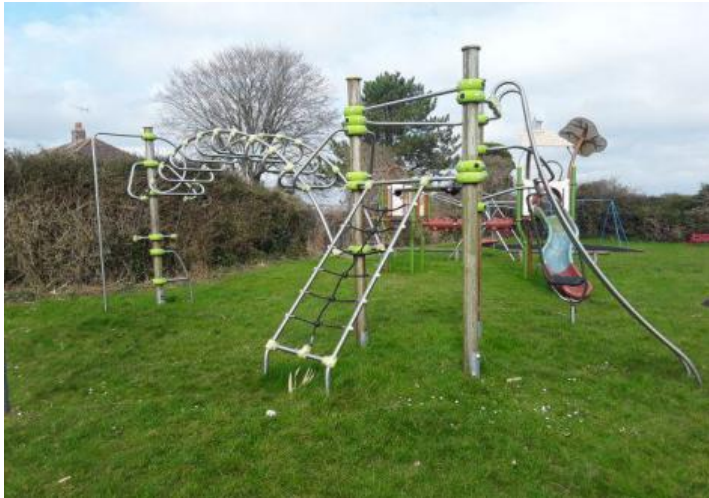
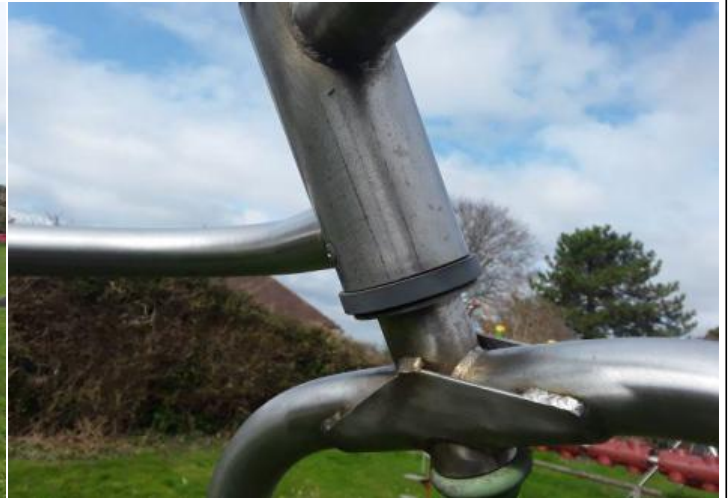
Item: Activity Equipment - Multi Play (Junior)
Manufacturer: Proludic

Finding: The spinning platform bearing is showing signs of wear

Action: Monitor for any further deterioration and replace as required

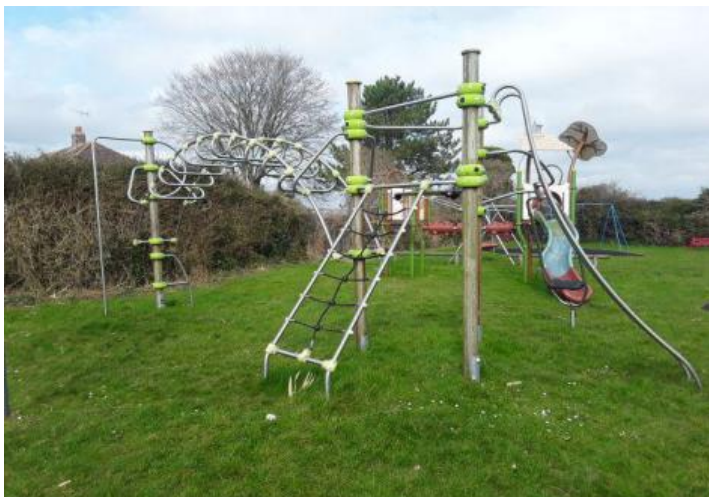
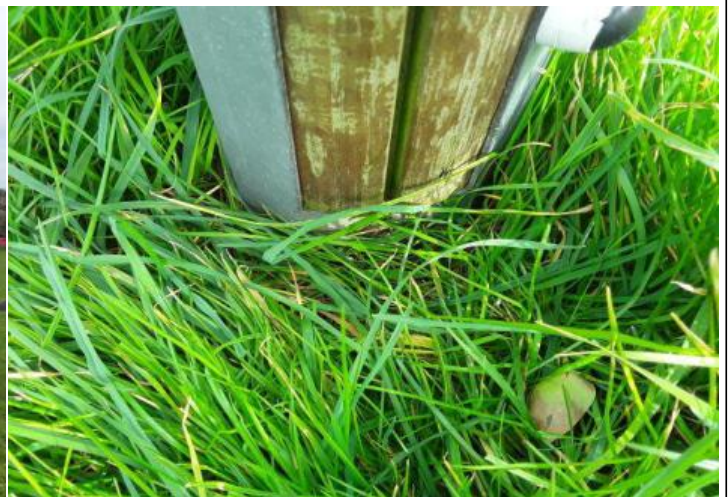
Item: Activity Equipment - Multi Play (Junior)
Manufacturer: Proludic

Finding: There is some strimmer / machinery damage apparent on the posts, this can penetrate the preservative applied to the timber and accelerate the rotting process

Action: Monitor for any deterioration (rot) and replace as required
