Play Area Inspection _____ 11

Inspected: 10-March-2022 - 12:59 by Leon Pope RPII Annual Inspector

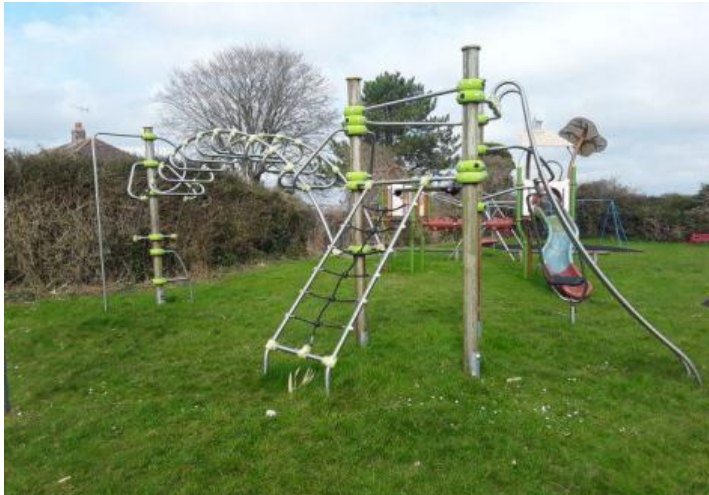
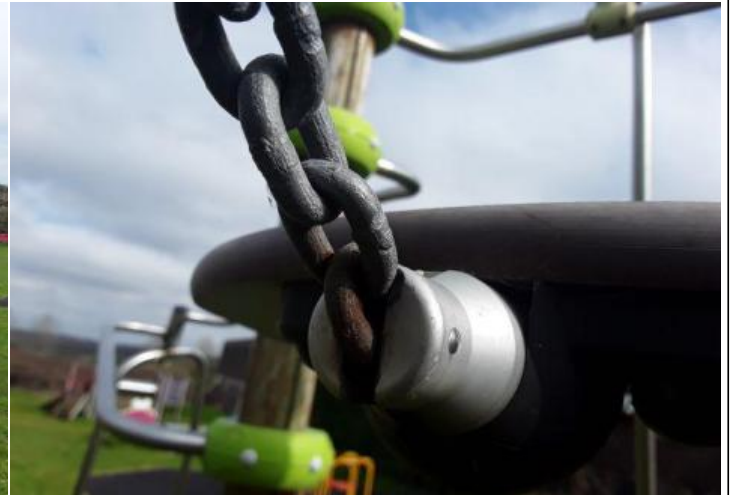
Item: Activity Equipment - Multi Play (Junior)
Manufacturer: Proludic

Finding: There is some notable evidence of chain wear

Action: Monitor for any further deterioration and replace when 40% worn

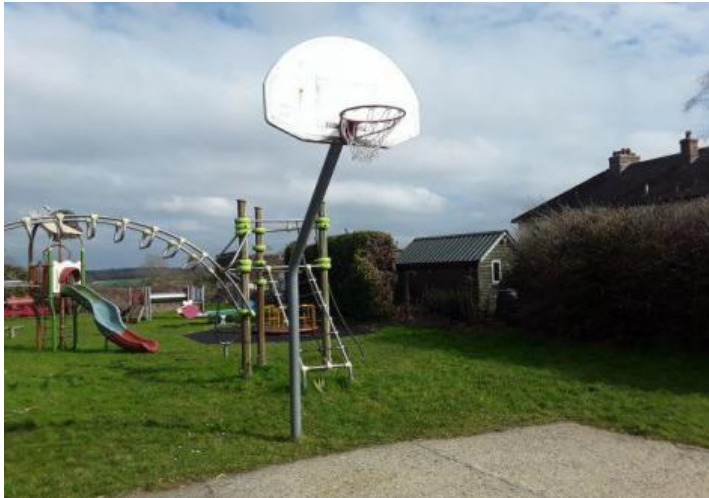
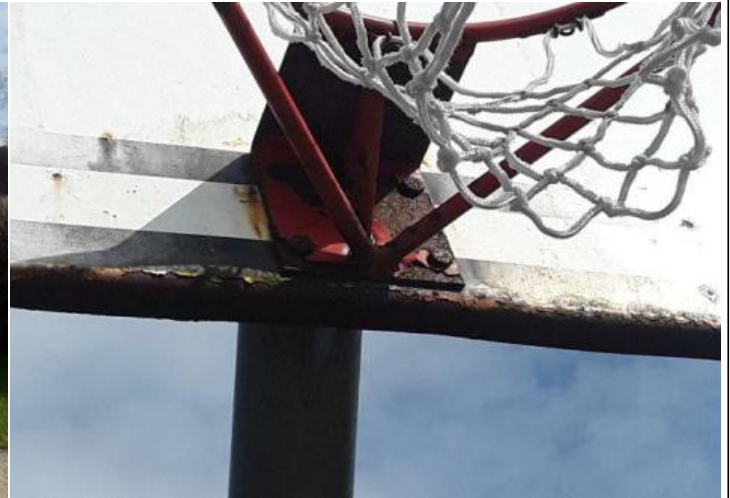
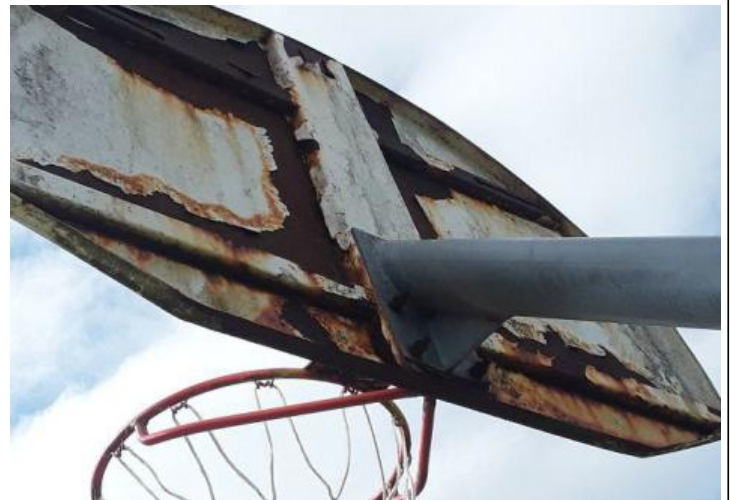
Item: Multi Use Games Area - Basketball Post
Manufacturer: Sure Shot

Finding: The paintwork on this item has been damaged or worn exposing the metal underneath which is rusting

Action: Treat any rusting components and repaint

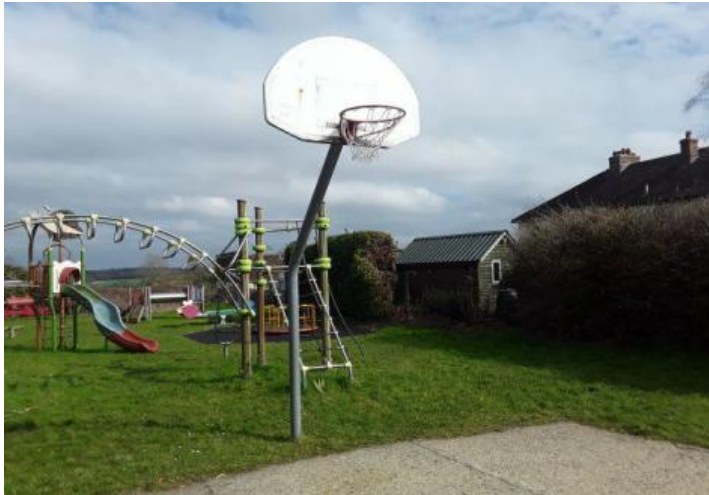
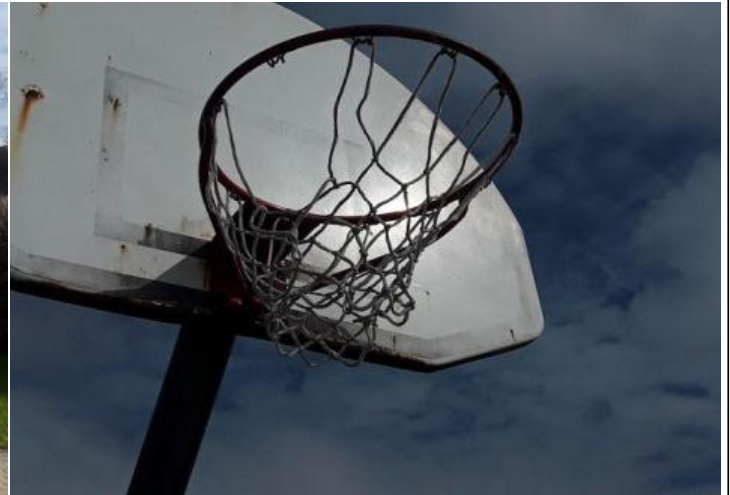
Item: Multi Use Games Area - Basketball Post
Manufacturer: Sure Shot

Finding: The net is loose

Action: Secure

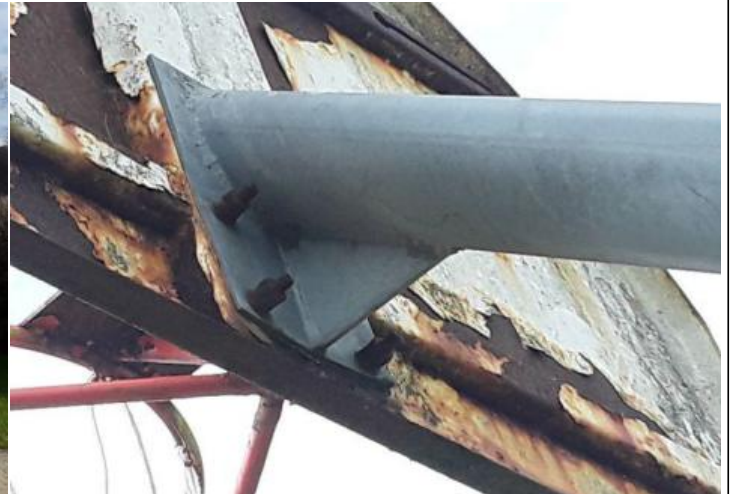
Item: Multi Use Games Area - Basketball Post
Manufacturer: Sure Shot

Finding: There are projecting bolt thread(s) present

Action: Remove excess thread length and deburr or provide cap
